# Monitoring of the Extent of Surface Waters of an Inactive Post-Flotation Reservoir as an Element of its Safety Assessment

Wojciech JAŚKOWSKI<sup>1)</sup>

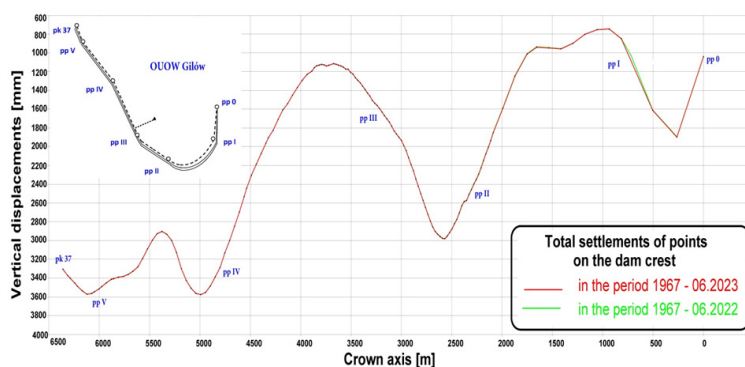
Fig. 3. Total settlements of points on the dam crest

The measurements from June 2023 show that the crown of the embankment has been lowered, reaching ordinates from 178.0 to 175.3 m above sea level. compared to the original elevation of 179 m a.s.l. (Fig.3)

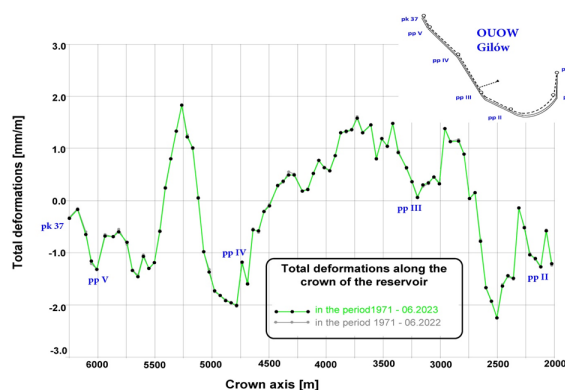
Fig. 4. Total deformations along the crown of the reservoir

The horizontal deformations of the control sections, which are located on the section of the dam from 2500 m to its end, have been determined since 1973. They range between  $-2.25$  mm/m in the vicinity of 2500 m (and this is the highest value of compressive deformations along the dam crest, slightly higher than the value found in previous observation periods) and  $+1.59$  mm/m on the section of 3800 m (Fig.4) and do not pose any threat to this type of engineering structure what is an earth dam.

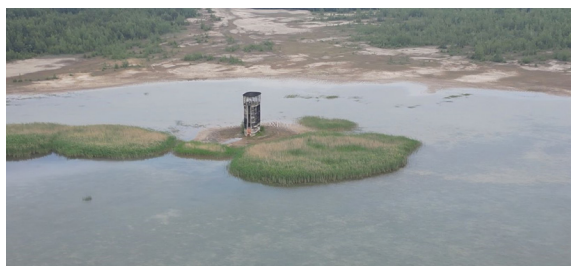
Due to the significant reduction of the basin, from mid-1989, overflow tower no. 2 ceased to operate automatically. If the basin periodically came closer than 100 m to the embankment, water was pumped out to the overflow tower, draining the water outside the landfill by gravity by means of a return water pipeline.

Fig. 6. Photo of the disused overflow tower No. 2  
Rys. 6. Zdjęcie nieczynnej wieży przelewowej nr 2

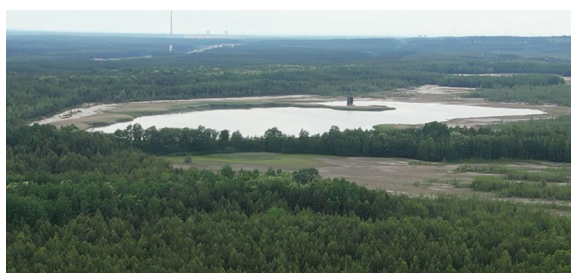
Fig. 7. Photo of the floodplain in the sediments of the Gilów mining waste disposal facility  
Rys. 7. Zdjęcie powierzchni zalewowej w osadach obiektu unieszkodliwiania odpadów wydobywczych Gilów

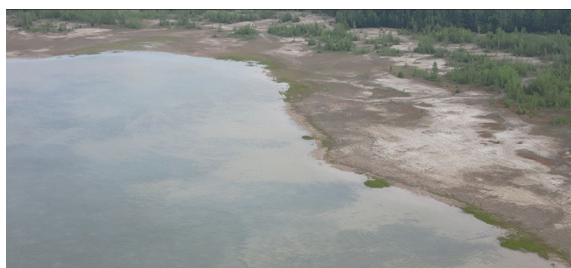
Fig. 8. Photo of the shoreline of the floodplain in the settlements of the Gilów mining waste disposal facility  
Rys. 8. Zdjęcie linii brzegowej zalewiska osadnika w obiekcie unieszkodliwiania odpadów wydobywczych Gilów

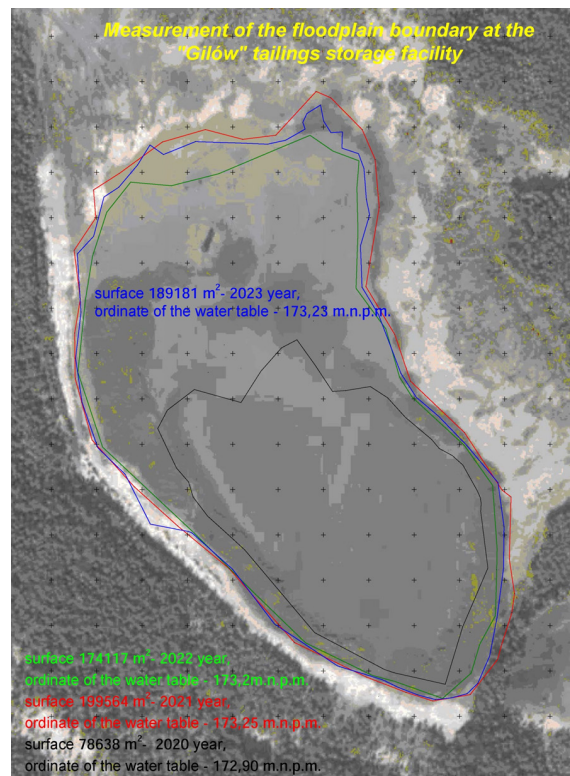
Fig. 9. Measurement of the floodplain boundary at the "Gilów" tailings storage facility  
Rys. 9. Pomiar granicy powierzchni zalewowej na terenie składowiska odpadów wydobywczych „Gilów”

Figure 9 summarizes the results from June 2020 to June 2023 (Fig. 9).

The average height of the water table reached its highest height in June 2021 and amounted to 173.25 m. In June 2023 it slightly decreased to 173.23 m (Fig.9). The lowest value was recorded during measurements in June 2020 and it was 172.90 m. Along with the increase in the height of the water table, the area of the floodplain increases from 78 thousand. m<sup>2</sup> in 2020 to 199,000 m<sup>2</sup> in 2021. In June 2023, the area of the floodplain is approximately 189,000 m<sup>2</sup>. Analyzing changes in the area of the floodplain in comparison with the data of the Polish Institute of Meteorology and Water Management – National Research Institute, one can see correlations between the annual sums of precipitation in the vicinity of Lubin and the size of the floodplain. In 2019, the sum of precipitation was about 500 mm and in the following year, 2020, it was over 600 mm. The greatest rainfall was recorded in 2021, about 750 mm, which in the following year, 2022, amounted to 650 mm. In the vicinity of the Gilów. Reservoir, the highest rainfall occurs in June-July and on average it is about 80 mm/month.
