# Mining Activities in the České Středohoří Mountains Protected Landscape Area

## Abstract

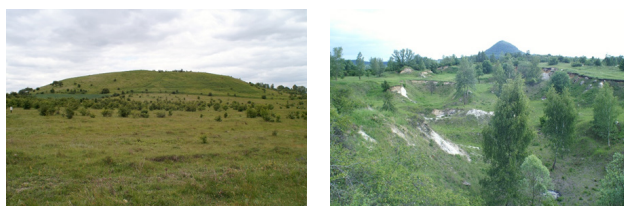
Fig. 2. The Písečný vrch near the village of Bečov  
Rys 2. 2. Písečný vrch w pobliżu wsi Bečov

This maar was a rich source of quality quartzite in prehistoric times. The hill is now covered with scrub (here the situation in 2009).

maar of Písečný Vrch – Sandy Hill – near the Village of Bečov) (Fig. 2). The main phase of utilizing local sources came with the medieval development of residential places. Nevertheless, there was no serious survey; old drawers simply used to set-up quarries and extract sources until they stroke altered rocks, tephra or their hardened forms.

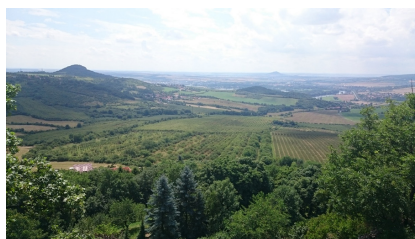
Fig. 3. The Radobýl is a lonely hill near Litoměřice and was exploited in two ways – in addition to a large wall quarry on the western slope, quality limestone was mined here by a system of underground chambers

Radobýl – described in the following chapter (underground limestone mining) it was also affected by a huge, abandoned shelf quarry (Fig. 3).

crust. After this crust is damaged or eroded, loosened grains screen out and the process can continue deeper and deeper. There are also abandoned limestone deposits – for example Radobýl (Fig. 3 above) hill near the City of Litoměřice. The deposit was accessible via an adit below the volcanic complex. During the WWII, the underground labyrinth was utilized by Germans for producing aerial components, having its own “accessory” concentration camp and even its crematory. Now inaccessible, the mine serves as the deposit of radioactive wastes from hospitals and laboratories.

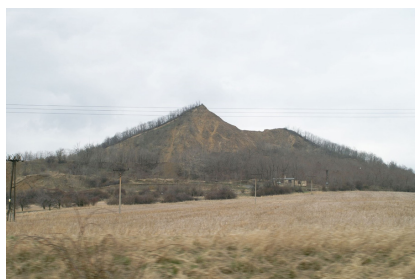
Fig. 4. The Vršetín u Podsedic was abandoned in 2008. The quarry is situated inside the PLA and is an example of complete destruction of a landscape dominant

Vršetín – the hill is a typical example of an absolutely devastated landscape dominant. This hill near the village of Podsedice lost its original profile, being only a torso now (Fig. 4).

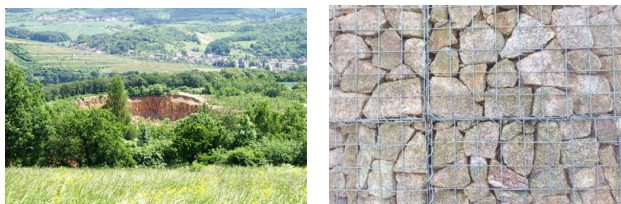
Fig. 5. The Kubo quarry near Malé Žernosky is almost perfectly hidden inside the terrain above the Labe river (left bank). Quarry stone as one of the products; here the filling of gabions

Kubo – established in 1842, this open pit quarry is almost perfectly hidden in the terrain above the Labe river (left bank). Lying some 3 km from the City of Lovosice center, it is still the source of superior construction stone (walls, beddings, gabions, decorative elements (the stone is cut or cleaved and polished) and even of various crushed fractions for transportation purposes (Fig. 5). The stone is probably of the Carboniferous age, being a part of the so called Altenberg Caldera. [16]

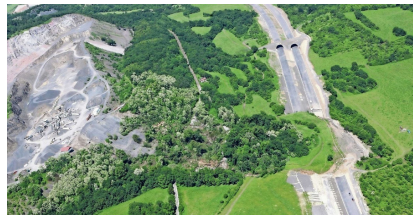
Fig. 7. The 2013 landslide at its largest extent. The thin silvery line represents the damaged and still non-functional railway line [20]  
Rys. 7. Osuwisko w 2013 roku. Cienka srebrzysta linia przedstawia uszkodzoną i wciąż nieczynną linię kolejową [20]

being a very expressive landscape element. The enterprise suffers from very disfavoured geological conditions. There are layers of altered rocks (potential slide surfaces) but their exact extent is not well known. In 2013 (after heavy rains) a devastating landslide occurred below the bottom edge of the quarry. The slide destroyed a part of local railway between the cities of Teplice and Lovosice; it also covered the new D8 highway (Fig. 7).

After difficult sanitation works, the landslide was removed, and the adjacent slope stabilized. The highway contractors (as well as the Czech Ministry of Transport) have accused the quarry (and vice versa) – the plea still continues. According to public sources, contractors have been more successful, but the judgment has not been final yet. In any case, geologists claim the area to be highly unstable and the highway has to be carefully monitored: Now several words about the highway itself. Its construction was planned for more than 80 years with the only aim – to connect Prague and Dresden. Much later, (after 1989) the aim was to decrease the transit traffic load along the river Labe.

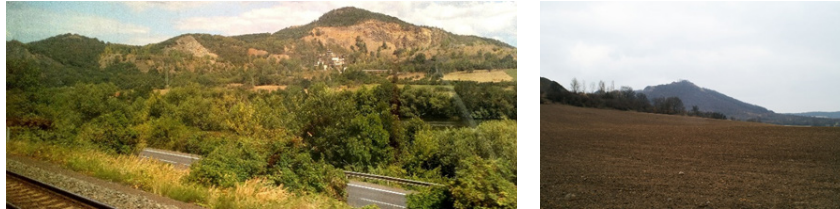
Fig. 8. Deblík, the highest hill slightly to the right, is now only a technological base (left); mining takes place in neighbouring Trabice; Trabice and the broken horizon line (right)  
Rys. 8. Dęblik, najwyższe wzniesienie (nieco po prawej stronie), to obecnie jedynie baza technologiczna (po lewej); wydobywanie odbywa się w sąsiednich Trabicach; Trabica i przerwana linia horyzontu (po prawej)

Libochovany – the series of basalt quarries is situated opposite to Dobkovičky on the right Labe riverside. The oldest quarry at the railway is full of debris; it was abandoned long ago as well as other minor developments. The first successful quarry was exploited inside the hill called Deblík (Fig. 8); because of altered rocks, working was shifted into the hill known as Trabice. This open pit quarry changes the hill into a torso as well.

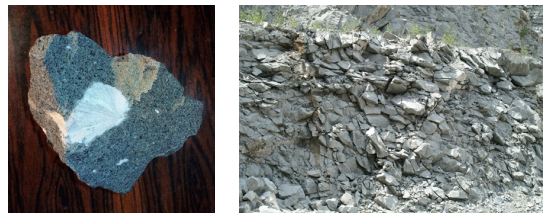
Fig. 9. Natrolitic trachyte, mined by the quarry in Mariánská skála; fracturing of the rock as a result of stress relief during the outcrop of the massif (laccolith) during Saxon tectogenesis  
Rys. 9. Trachit natrolitowy, wydobywany w kamieniołomie w Mariańskiej Skale; pęknięcie skały w wyniku odprężenia podczas wychodni masywu (lakkolitu) w okresie tektogenezy saksońskiej

Mariánská skála (Marienberg) in Ústí nad Labem – this open pit quarry was established inside a huge massif near the Ústí nad Labem center. In medieval times, the rock was a good source of construction material which enabled to build the whole borough by virtue of smaller quarries. Originally the massif extended into the Labe river; rocks had to be partly blasted off because of building the railway line between Prague and Děčín (later Dresden). J. E. Hibs, a famous Vienna mineralogist, called the stone Marienbergite (he often saw minor differences in mineral composition and called such rocks according to the place of their occurrence). Of course, from the present-day point of view it would be somewhat impractical – the rock is generally called phonolite and more exactly natrolitic trachyte (Fig. 9a) [8]. The quarry itself was opened inside the massif; because of strict spatial limits, it could only proceed downwards to the level of about 90 meters below the rock surface (present day situation). The stone seems crushed (Fig. 9b) but reasons are very different. The massif (called laccolith) was slowly uplifted and after opening the quarry, the internal stress got loose. The future of this quarry is not sure; spatial limits are still very strict.
