# Monitoring of the Extent of Surface Waters of an Inactive Post-Flotation Reservoir as an Element of its Safety Assessment

Wojciech JAŚKOWSKI<sup>1)</sup>

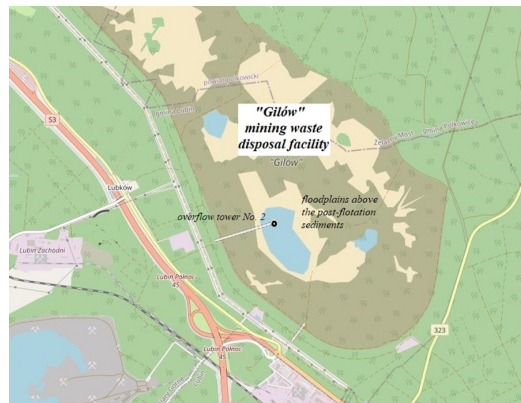
Fig. 5. Map of the location of floodplains above the post-flotation sediments  
Rys. 5. Mapa lokalizacji terenów zalewowych nad osadami poflotacyjnymi

mechanical processing of the ore. The water level has been systematically lowered since 1980. The depth and size of the basin made it possible to keep the overflow tower in continuous operational efficiency. The observed phenomenon of meandering of the overlying basin was mainly related to surface depressions as a result of the exploitation of the protective pillar. The width of the beach along the entire embankment was always greater than the minimum allowable width of 100 m.
